Vinyl (PVC) products such as tile, plank, sheet flooring and vinyl back carpet and tiles should never be installed directly over cutback residues. Black asphalt-based cutback adhesive is highly reactive to vinyl back flooring and must be completely removed until there are no remaining continuous film or trowel ridges. Any remaining residue or stain must also be encapsulated.

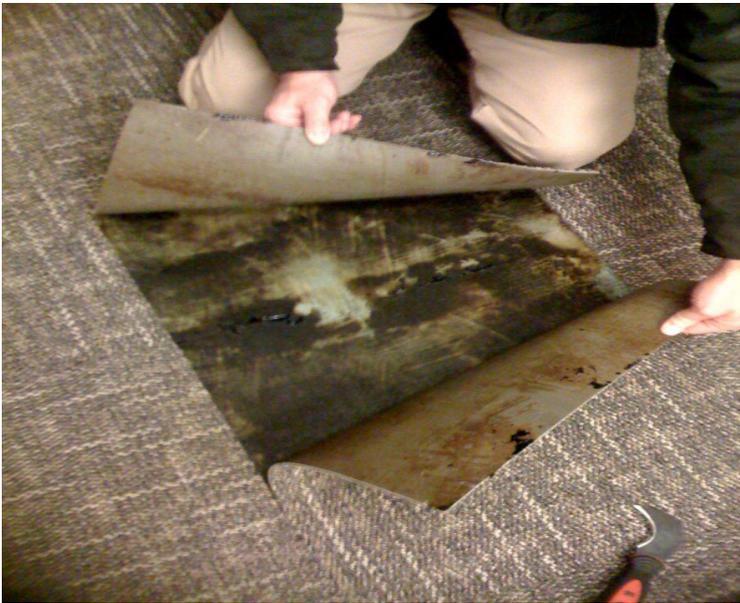
If vinyl backed flooring is placed over cutback adhesives, plasticizer can migrate from the vinyl backing into the cutback, causing it to become soft or liquid. The adhesive bond will be lost, and the cutback may bleed to the flooring surface. See photo of cutback bleed-through with vinyl-backed carpet tiles.

Abatement of cutback adhesive residue may also be accomplished by encapsulation. Cementitious, epoxy, or other aqueous polymer based compounds are sometimes used to form an isolation barrier between the cutback adhesive residue and new adhesive and flooring.

Where no asbestos is present, remove existing cutback adhesives by wet scraping, grinding or bead-blasting, avoiding the use of solvents. In all cases, cutback residues should be reduced to the least amount possible. XL Brands/Bostik does not recommend the use of liquid solvent or surfactant adhesive removers, as they can be absorbed into the concrete and cause problems with subsequent flooring installations.
